REDUCING BACTERIA WITH BEST MANAGEMENT PRACTICES FOR LIVESTOCK

STREAM CROSSING

NRCS CODE 578

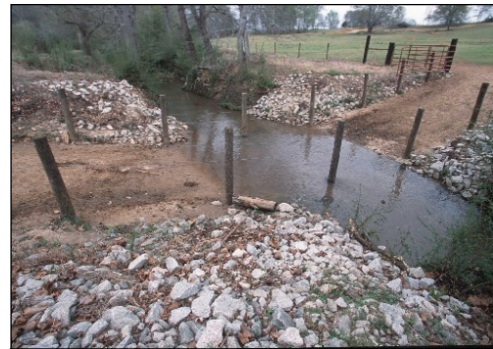
Concrete water crossing for livestock. Photo by Jeff Vanuga, NRCS.

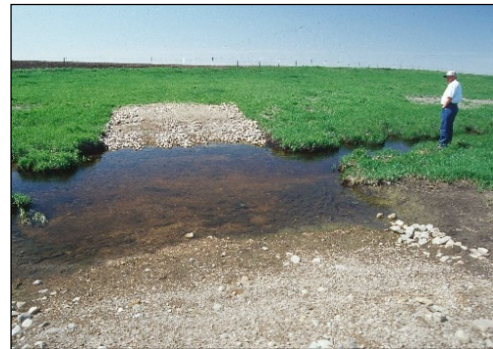
This livestock crossing was installed to offer a stable point for livestock to cross a stream. This low cost engineering practice is an efficient method of reducing bank erosion. Photo by Don Poggensee, NRCS.
